Holiday Inn Haydock M6 J23 - Leisure Facilities

Leisure Facilities Introduction

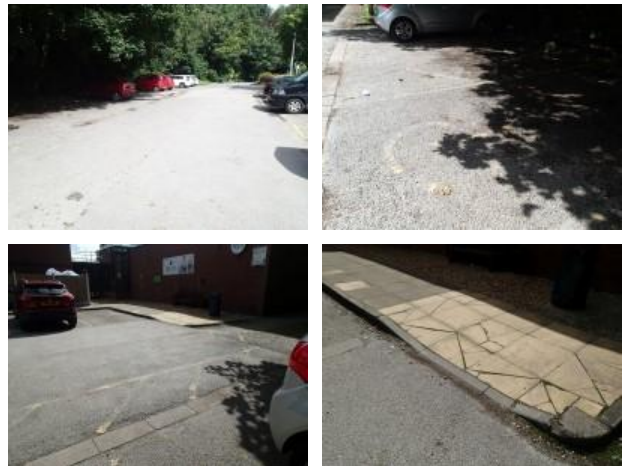
- The hotel does have its own parking facilities.
- The car park is located at the rear of the hotel.
- The car park type is open air/surface.
- The car park does not have a height restriction barrier.

- The car park does not have a barrier control system.
- The car park surface is tarmac.
- There is a/are Blue Badge parking bay(s) available.
- The Blue Badge bay(s) markings are faded.

- There is/are 2 designated Blue Badge parking bay(s) within the car park.
- The dimensions of the designated Blue Badge parking bay(s) surveyed are 360cm x 500cm (11ft 10in x 16ft 5in).

- There is not a 120cm hatched zone around the Blue Badge parking bay(s).
- Parking spaces for Blue Badge holders do not need to be booked in advance.
- Clearly marked/signposted parent and child parking bays are not available.
